Case Study

Project: Corrosion mapping on caissons to detect and quantify wall thinning

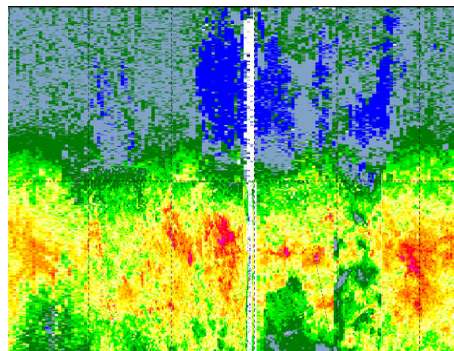
Sonomatic's MAG-Rover was used to collect corrosion mapping data at selected locations (Figure 1) with a width of 700 mm around the full circumference of the caisson. The corrosion mapping results (Figures 2 and 3) accurately define the condition of the caisson.

Figure 2: Corrosion mapping image from caisson inspection

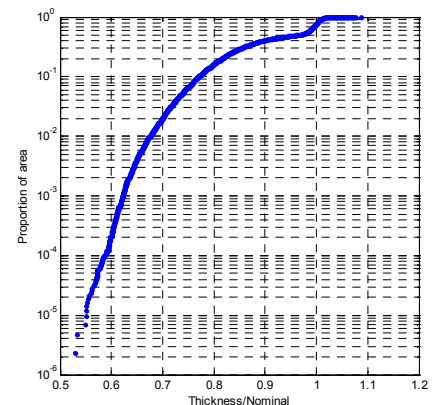
Figure 3: Wall thickness distribution
