Case Study

Project: Corrosion mapping on caissons to detect and quantify wall thinning

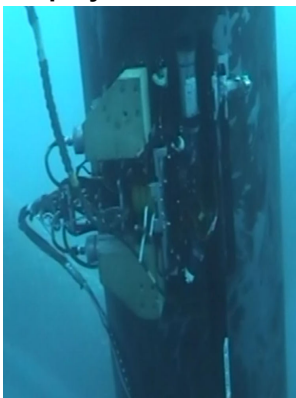
Figure 1: MAG-Rover deployed on caisson

Sonomatic's MAG-Rover was used to collect corrosion mapping data at selected locations (Figure 1) with a width of 700 mm around the full circumference of the caisson. The corrosion mapping results (Figures 2 and 3) accurately define the condition of the caisson.
